Disaster Shelter in the Philippines: Addressing the Occupants' Needs During and After Typhoon

**Asia Pacific Journal of
Multidisciplinary Research**

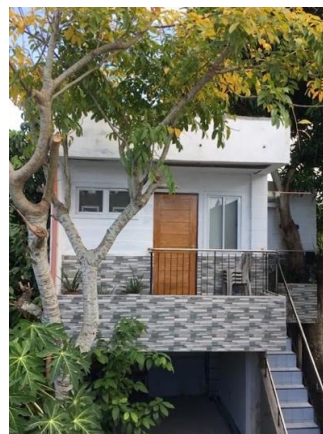
Figure 2. Façade of Disaster Shelter Facing West

The shelter on Figure 2 was designed as a reinforced concrete structure located at the second-floor level consisting of a 4 meters x 5 meters main structure and a 1.5 meters x 2.0 meters wing. The 20 square meter area was intended to function as living area, dining and sleeping while the 3 square meter area was provided for the toilet and bath, Figure 3.

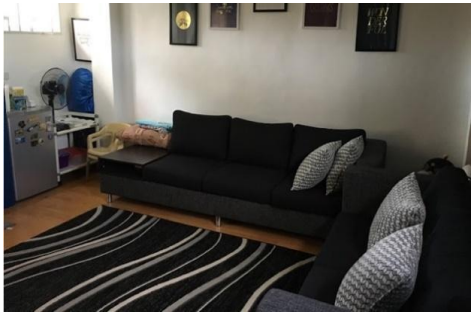
Figure 4. Wall at the North Side

Its walls facing the North and East directions were made to contain fewer windows or no window, Figure 4 and Figure 5. Its galvanized iron roof was concealed by higher walls and concrete gutter. Its windows were of sliding or awning type and the exterior doors were of the solid wood type. It was provided with water and electricity from the respective water and power utilities.

The shelter was also constructed on the second-floor level to protect it from the flood [16]. Because typhoons usually enter the Philippines from east to west but also towards the north [10], no window or fewer windows were made in the North side (Fig. 3.) and East side (Fig. 4). Also, to shield the galvanized iron roof from the strong wind, the surrounding walls were made higher than the roof, the purlins holding the roof were strongly embedded to the concrete roof beams and the gutter was made of concrete to protect itself and the roof [17]. To address the needs of the occupants during and after the disaster, the space requirements for sleeping, cooking, washing, toilet, and bath were provided [18]. Potable water supply in containers have always been provided for before the occurrence of typhoons and the shelter is connected to a water utility company; however, in case of water supply stoppage, domestic water needs have to be served by rainwater collector. The use of rainwater for domestic use has been done in other countries [19]. The shelter was connected to the main supply but it has a solar panel and a generator that served as a standby power supply.

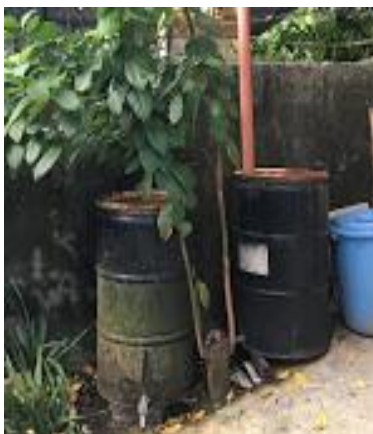
Figure 6. Simple Rainwater Harvester

A simple rainwater harvester, Figure 6, [13] and a solar-power-generated standby source, Figure 7, [14] and generator were made available.

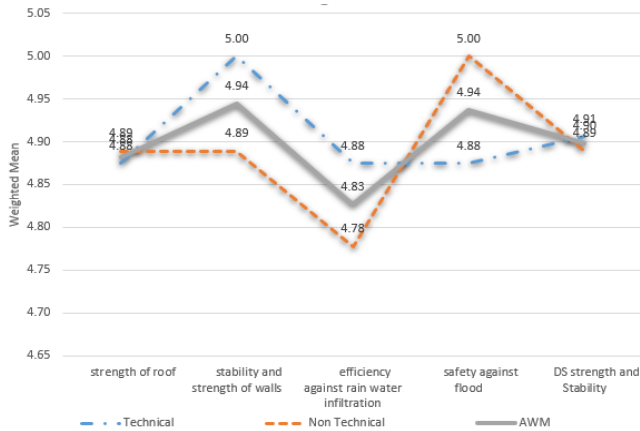
Figure 9. Acceptability of the DS in terms of Strength and Stability

As shown in Figure 9, there were four factors used to answer this question, to wit: the strength of roof, stability, and strength of walls, efficiency against rain and water filtration and safety against the flood. DS strength and stability was placed in the graph to show the average weighted mean (AWM) of the four factors. The non-technical group rated Efficiency Against Rainwater Infiltration as the lowest (AWM = 4.78), while the technical group gave an equal rating for Strength of the Roof, Efficiency Against Rainwater Infiltration and Safety Against Flood (AWM=4.88), its lowest. The non-technical group rated Safety Against Flood as the highest (AWM=5.0) while technical group rated Stability and Strength of Walls as its highest (AWM=5.0).

Both were fairly close in their rating of the DS Strength and Stability with AWM=4.89 for the non-technical group and AWM=4.91 for the technical group. The total average weighted mean (AWM) for this question from both groups was computed to be AWM=4.90, considered very satisfactory.

All the ratings given were within the very satisfactory range of the Likert scale. The location of the disaster shelter was probably considered by the non-technical group why it was rated AWM=5.0 for Safety Against Flood. The technical group must have considered the orientation of the structure and use of concrete for all walls as reasons why it gave AWM=5.0 for Stability and Strength of Walls. However, even if the rating of very satisfactory AWM=4.78 was given for Efficiency Against Rainwater Infiltration, the non-technical group must have a different alternative to further improve on this factor.
